# Unexpected— Earthquake 2011

Lessons to Be Learned

*Edited by  
A. Elena Charola,  
Corine Wegener,  
and Robert J. Koestler*

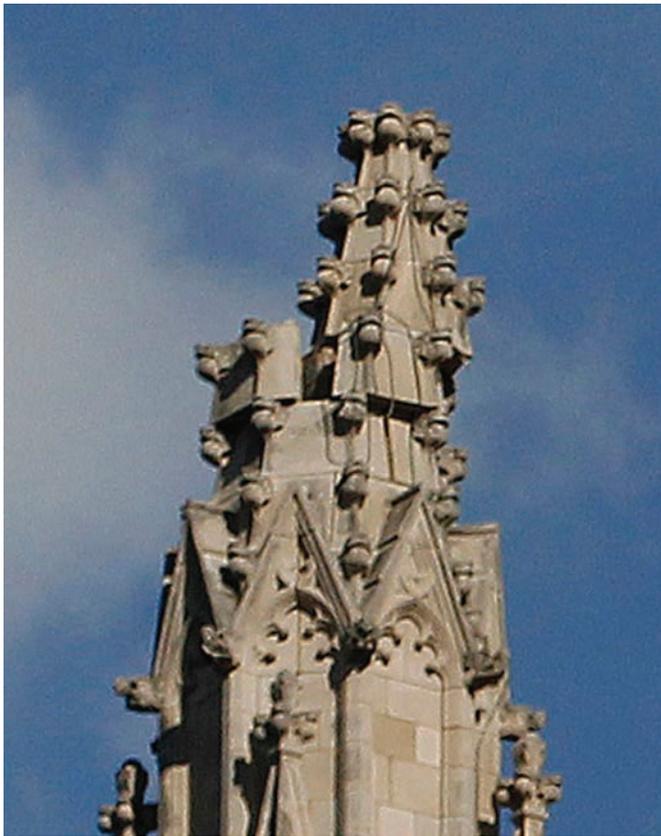
**FIGURE 9.** The National Cathedral in August 2008 and detail of damage it suffered in August 2011 during the largest earthquake to hit the region in more than 100 years. Note that long and spiky objects tend to suffer more—three of the four high spires at the top of the cathedral were damaged. (Photos: Cathedral, courtesy NCinDC, <http://www.flickr.com/photos/ncindc/2794096753>; spire detail, REUTERS, Jason Reed.)

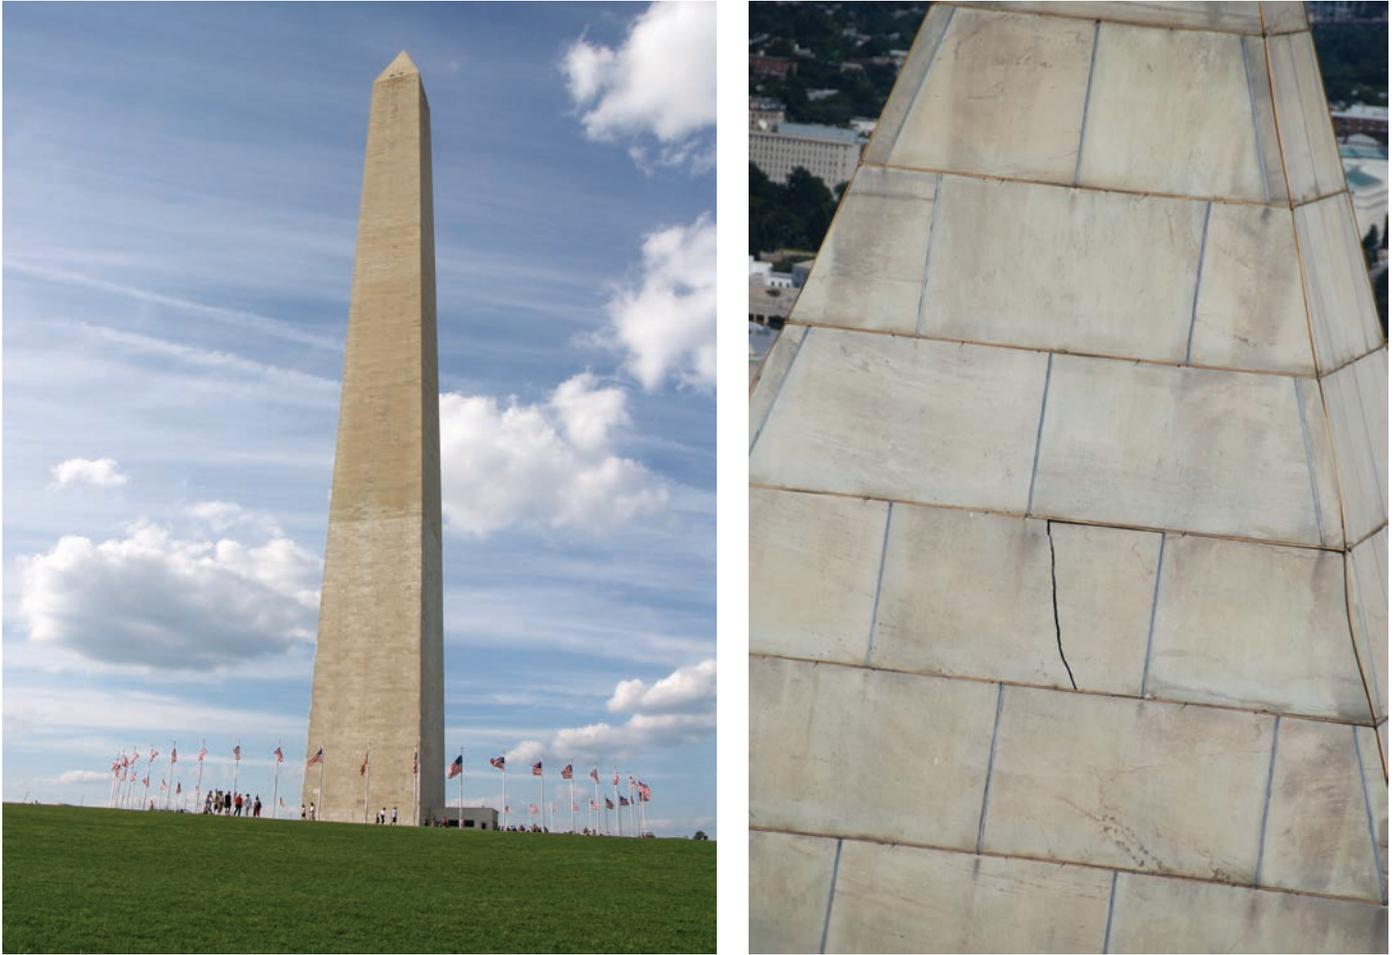
FIGURE 10. The Washington Monument in September 2005 (left) and detail of the crack that developed across one block on the pyramidion during the August 2011 earthquake (right). (Photos: left, courtesy Corey L. Kliewer, Washington, D.C., Convention and Tourism Corporation, [www.washington.org](http://www.washington.org) [<http://www.flickr.com/photos/wctc/79492470>]; right, National Park Service.)

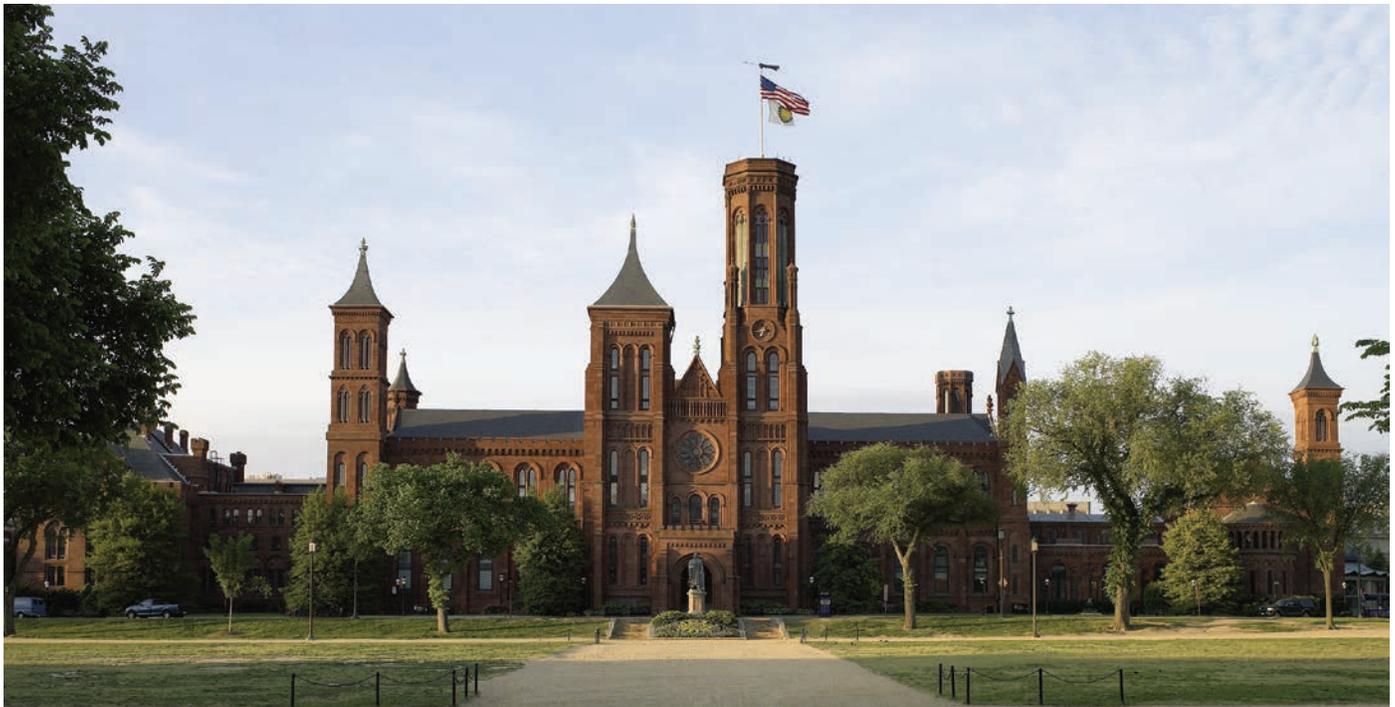
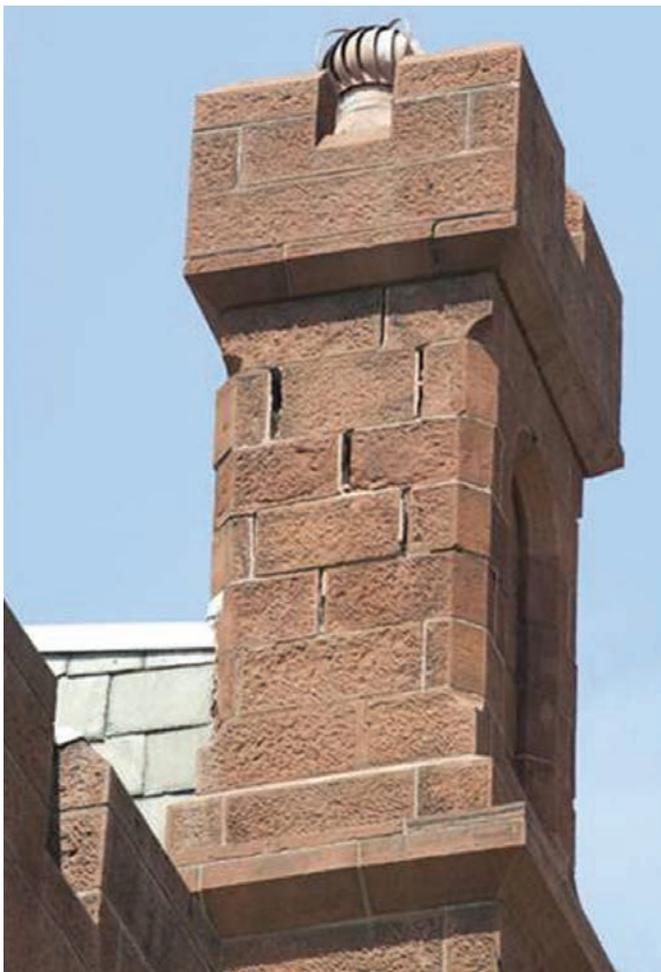
**FIGURE 11.** The Smithsonian Castle (above) and damage that some of the towers suffered as illustrated by the displacement of blocks in the chimney (detail, left). These blocks are high-quality Seneca sandstone and each one weighs some 68 kg (150 lb). (Smithsonian Institution photos: Castle, Donald E. Hurlbert; chimney detail, Mark Avino.)

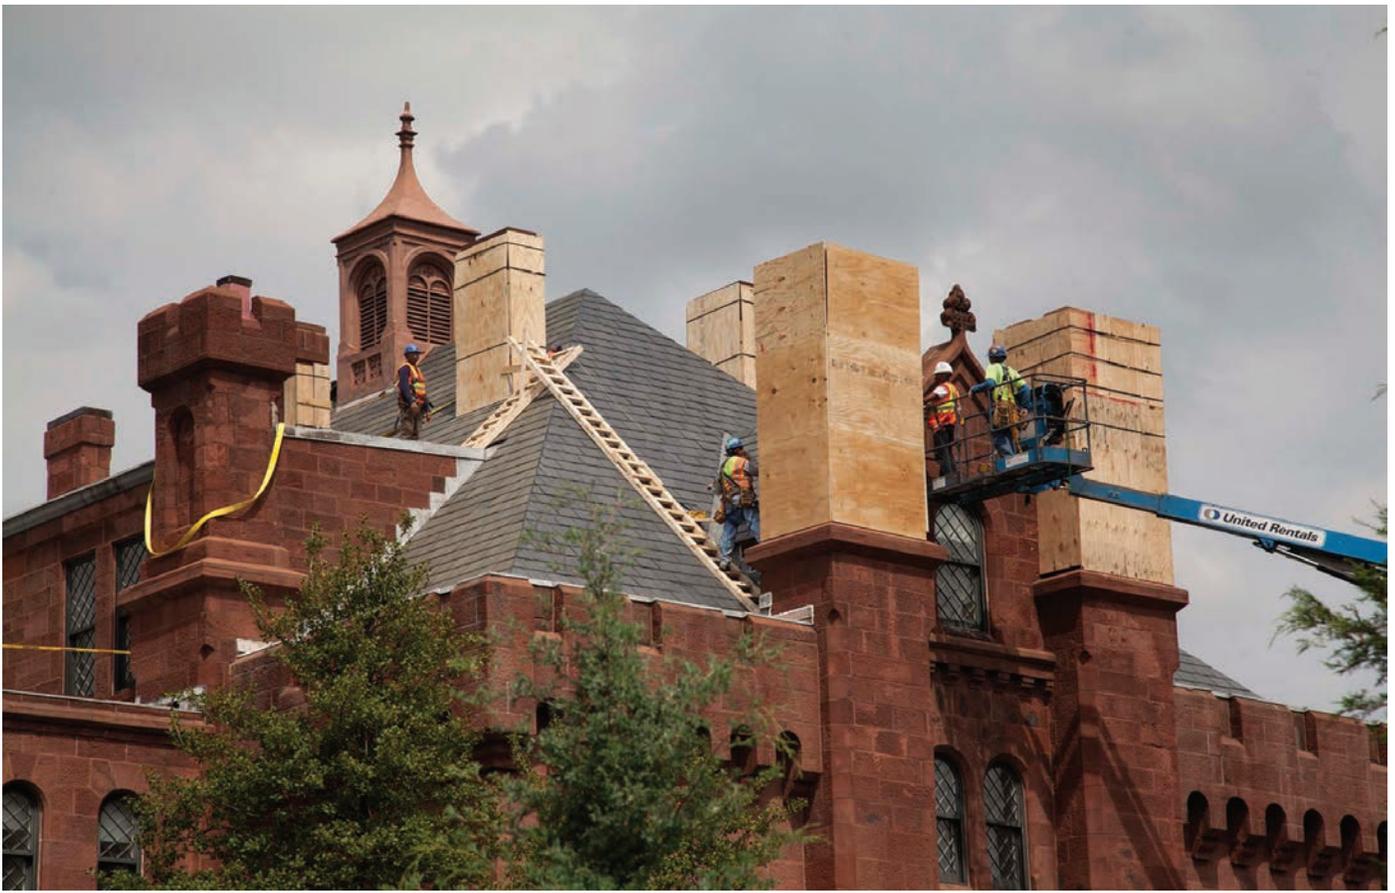
Not only was there damage to the chimneys and towers (Figure 13) but also to walls as evidenced by cracks in the interior of the building (Figure 14).

FIGURE 13. Stabilization of damaged stonework underway on 26 August 2011. (Smithsonian Institution photo by Eric Long.)

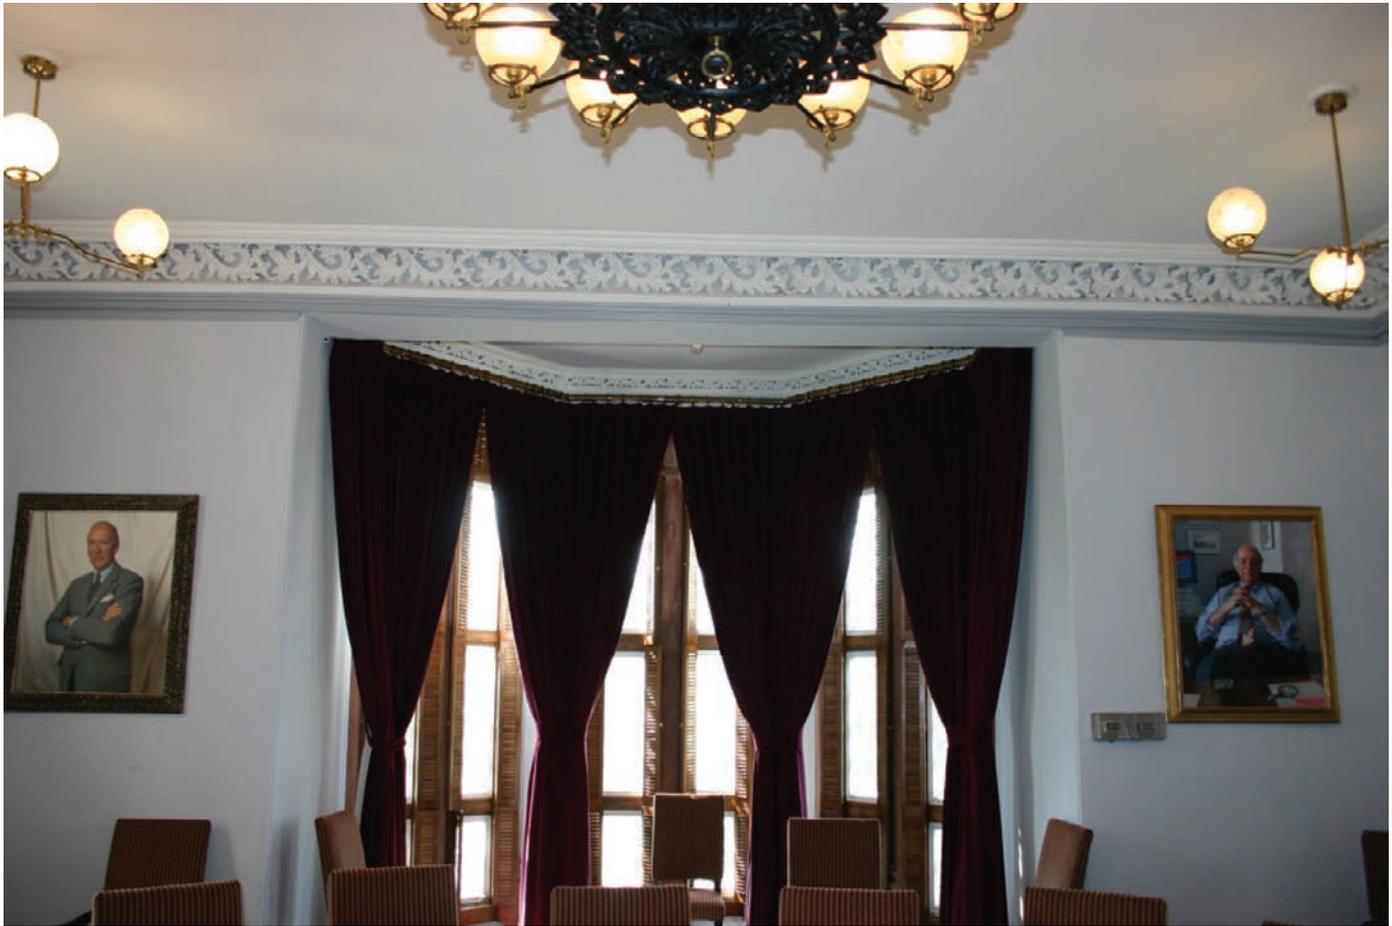
**FIGURE 14.** The Regent's Conference Room (above) developed a crack (detail, left) that runs through the beam over the bow window. (Smithsonian Institution staff photos.)

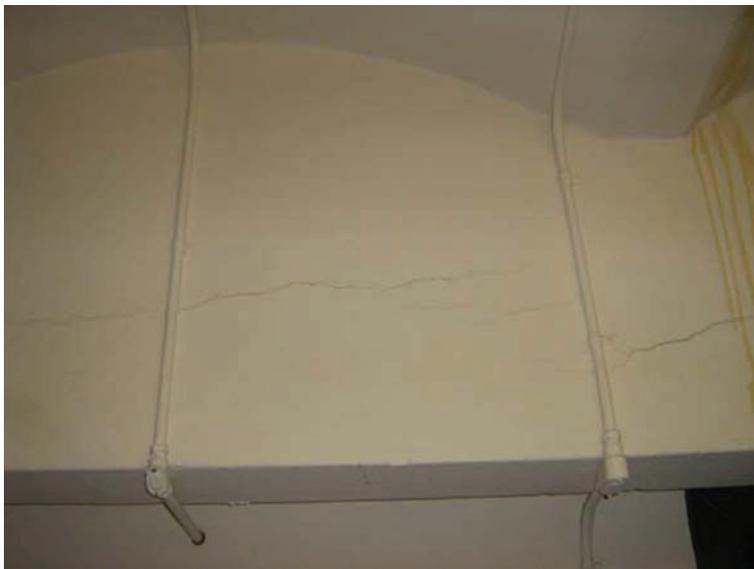
These additions are part of the problem that affected the building during the earthquake. The Main Building had not been designed to have additions attached to it. When the additions were made, each one used different structural systems and building standards, including seismological ones. Thus damage was induced as exemplified in Figure 16.

FIGURE 16. Damage to an original 1911 structural beam, basement of Main Building (left) and face brick separated where East Court building connects with Main Building at a bridge walkway (right). (Smithsonian Institution photos by James DiLoreto.)

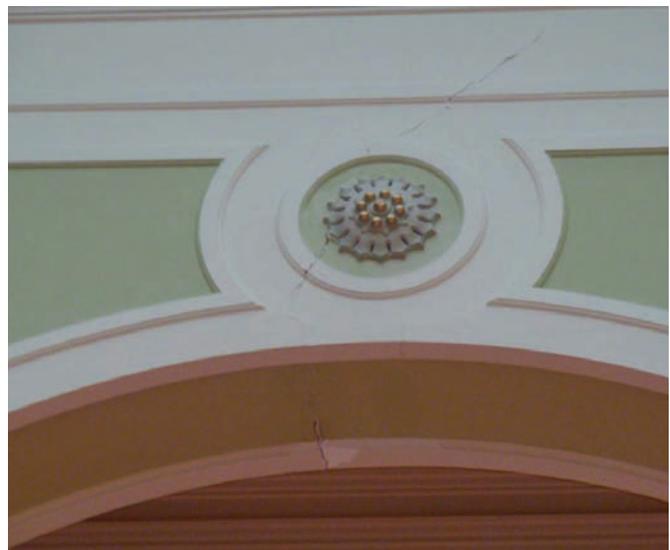
The damage was limited, with some cracks appearing in the Great Hall (Figure 18) of the NPG and the Luce Center of the SAAM (Figure 19). Because the cover structure of the central courtyard has a flexible joint it could move independently from the older masonry structure around it, avoiding significant damage.

FIGURE 18. Cracks in the Great Hall of the National Portrait Gallery, 26 August 2011. (Smithsonian Institution staff photo.)

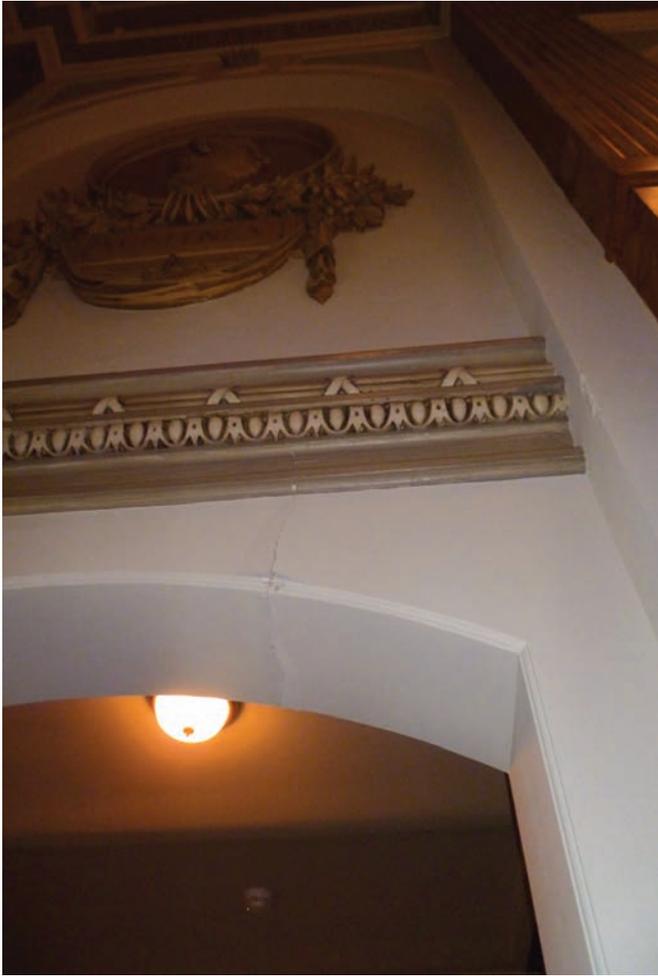
**FIGURE 19.** Cracks in the Luce Center of the Smithsonian American Art Museum, 26 August 2011 (Smithsonian Institution photo by James DiLoretto).

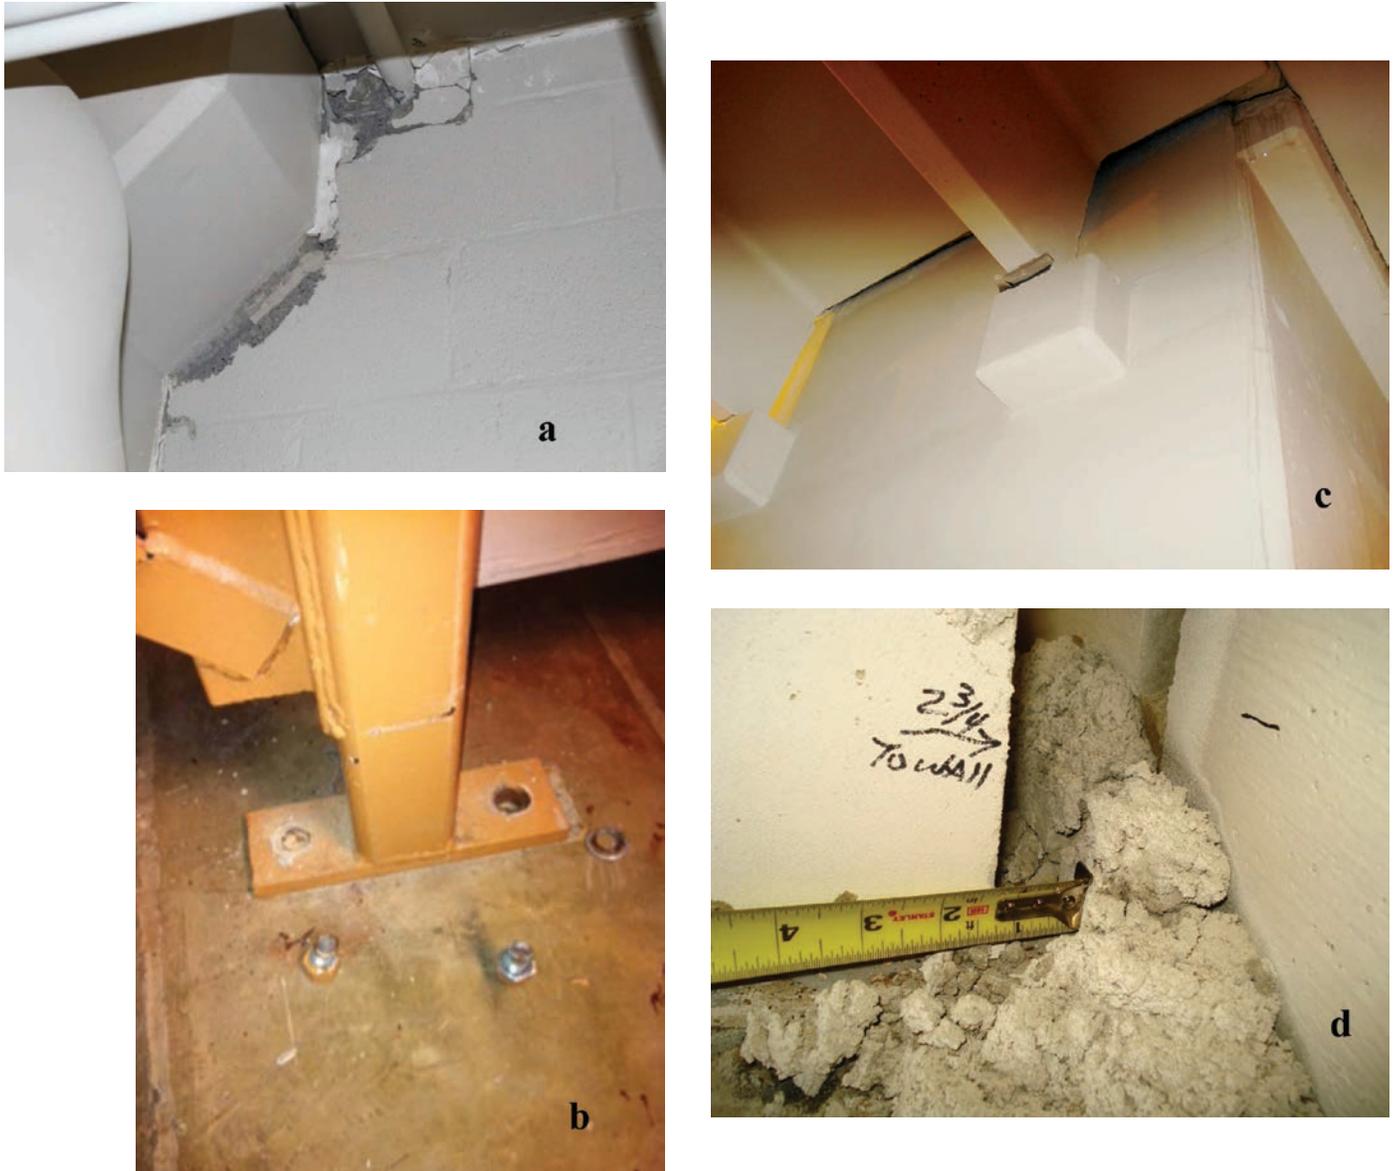
FIGURE 21. Pod 2 damage: (a) cracks along north wall; (b) bolts sheared off from floor; (c) a beam supporting another floor separated from its anchoring; and (d) one of the larger gaps that opened during the earthquake. (Smithsonian Institution photos by Office of Facilities Engineering and Operations staff.)

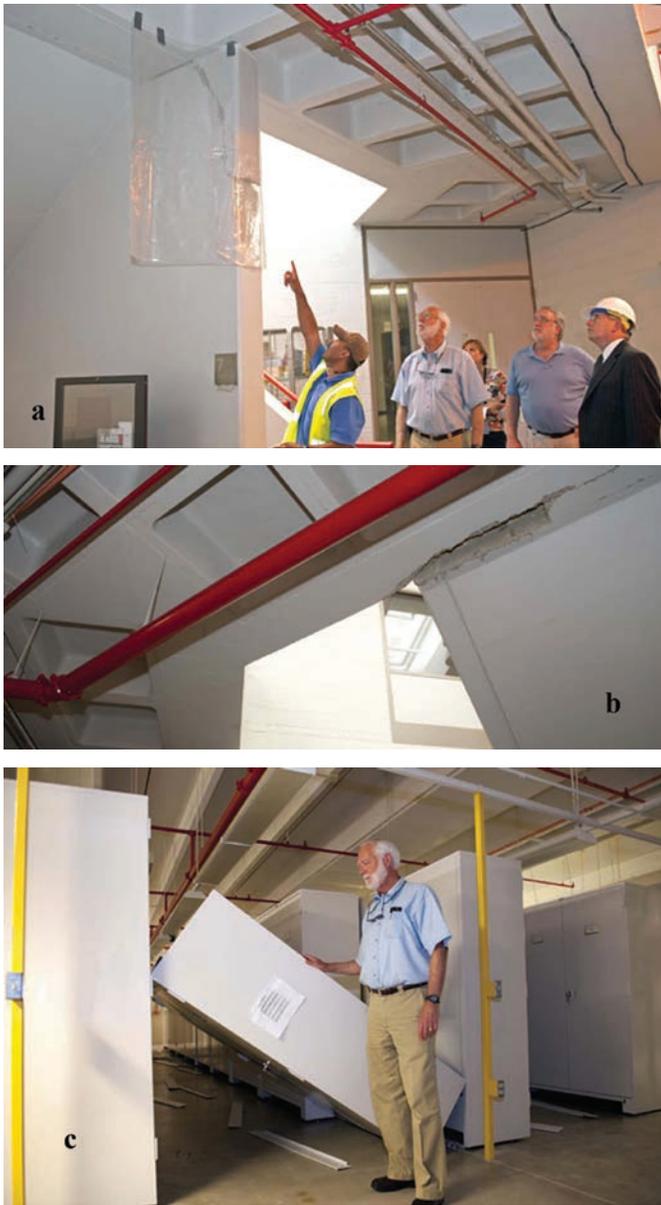
FIGURE 22. (a) G. Wayne Clough (second from left) and others examine a piece cracked off on “street” along Pod 3; (b) major crack along that same street; and (c) Clough examines an empty cabinet toppled over in mezzanine of Pod 1. (Smithsonian Institution photos (a, b) by staff and (c) by James DiLoreto.)

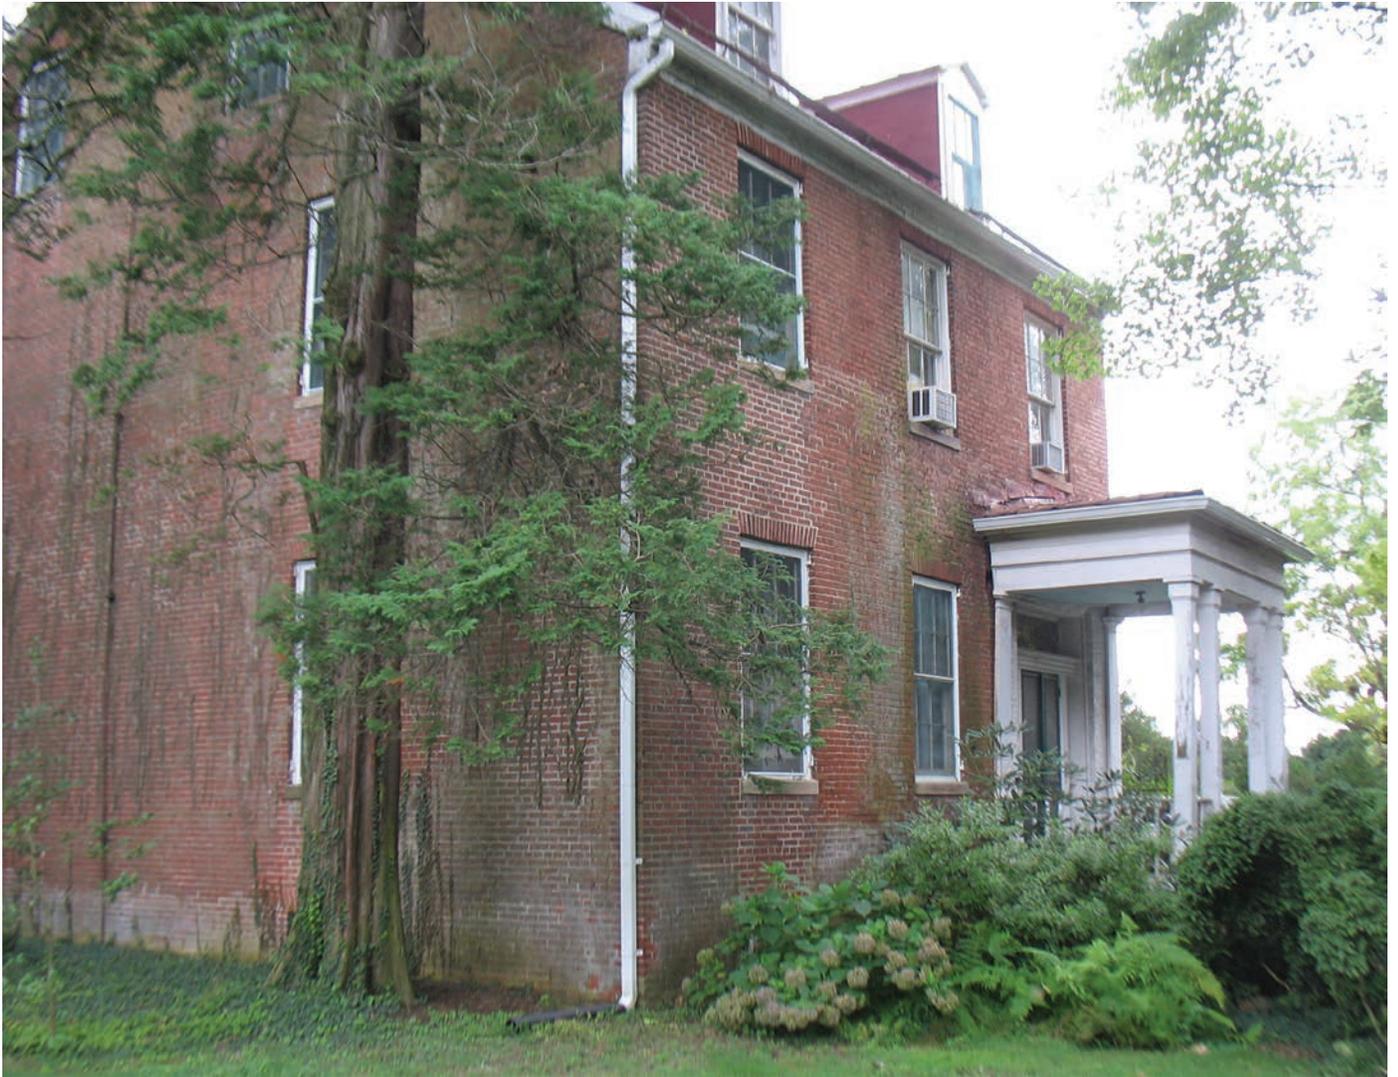
**FIGURE 7.** Exterior of the 1841 section, shown several months before the earthquake, was stable, but the masonry was in need of repointing as a result of deferred maintenance. This work along with a new standing seam metal roof was in the planning stages but was delayed because of the earthquake. (Photo by David Wright, GWWO, Inc./Architects.)

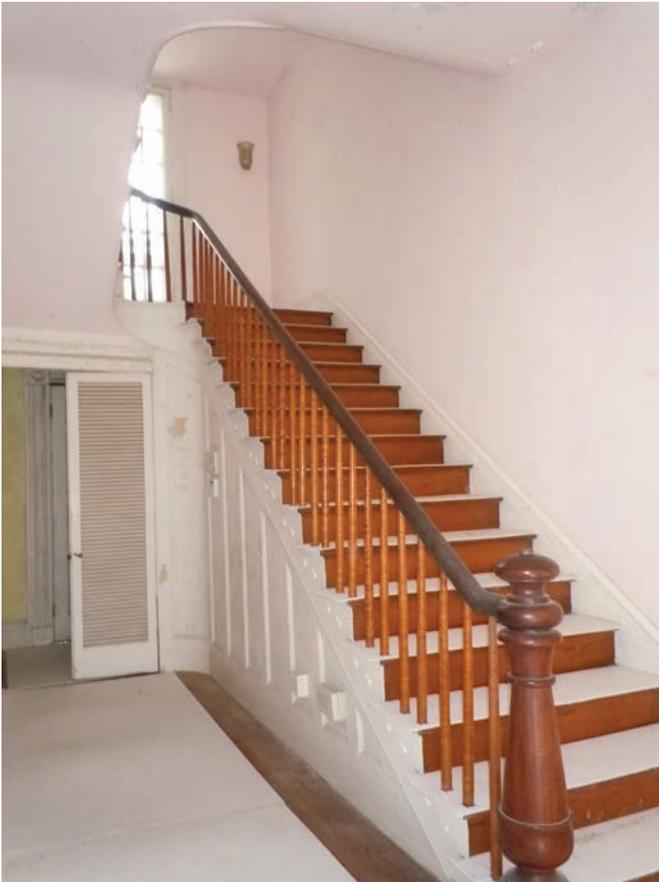
FIGURE 8. The interior after the earthquake. On the left is the handsome side hall staircase. On the right (above) is the wall between the two parlors showing the Greek Revival details of paneled doors, corner blocks in the door frames, and one of the black marble surrounded fireplaces. This wall was of concern as to its possible weakness in shear capacity structurally, but it had no visible cracks. (Photos: left, Raymond Jones, Smithsonian Institution; right, Sharon Park, Smithsonian Institution.)

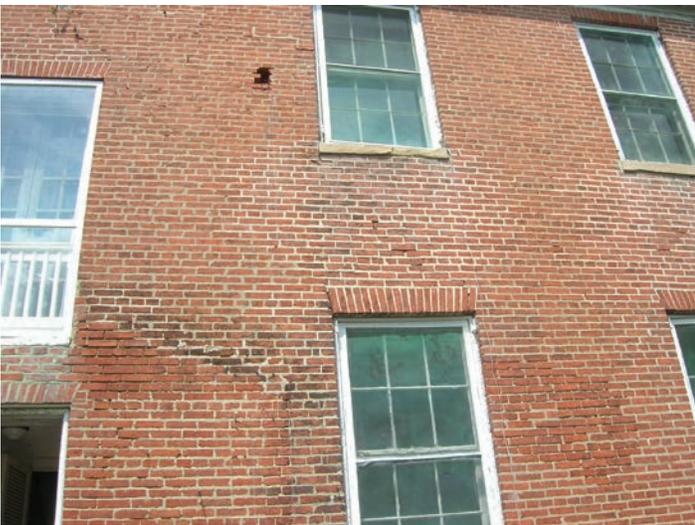
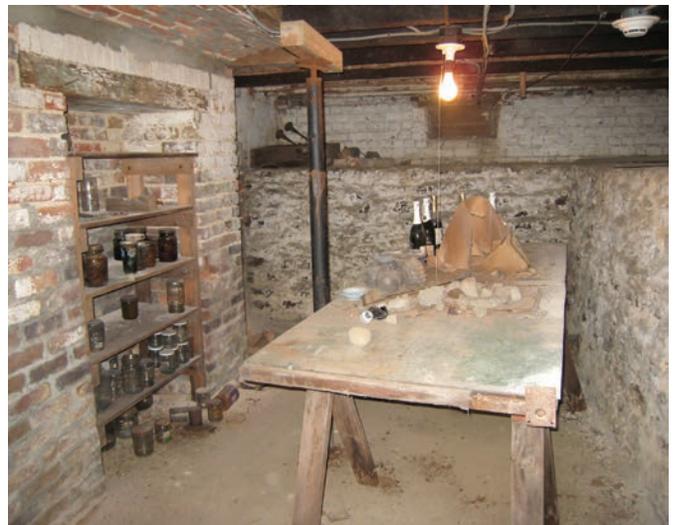
FIGURE 9. The exterior and interior of the 1841 section had suffered from deferred maintenance while the house was in a life tenancy situation. The exterior brickwork (left) was in need of repointing; and the basement (right) had a number of temporary bracing supports, which luckily kept the house from having major structural damage during the earthquake. (Photos by David Wright, GWWO, Inc./Architects.)

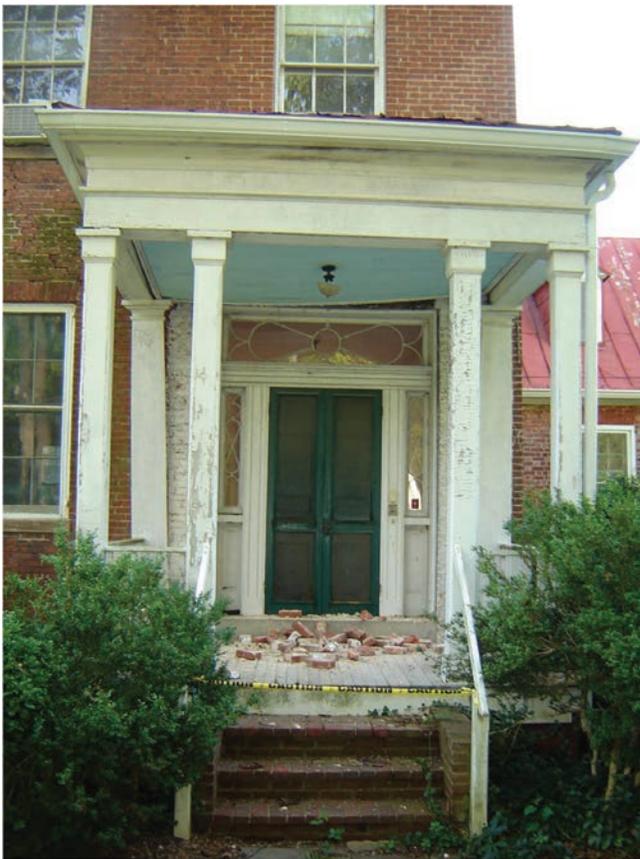
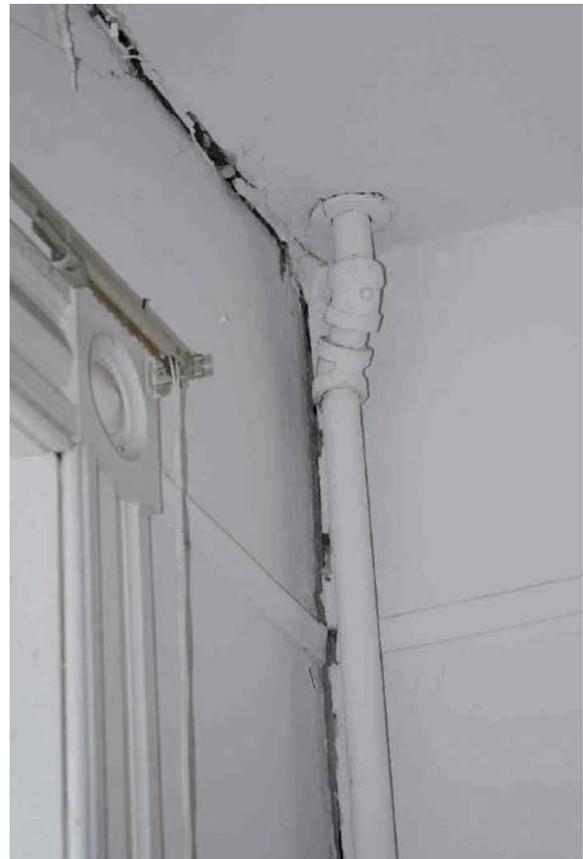
**FIGURE 10.** Exterior damage from the lateral movement created by the earthquake is seen in the pulling away of the front porch (left). Interior damage resulted in the separation of front and back walls from interior bearing walls and floor framing (right). (Photos by Steve Groh, Smithsonian Institution.)

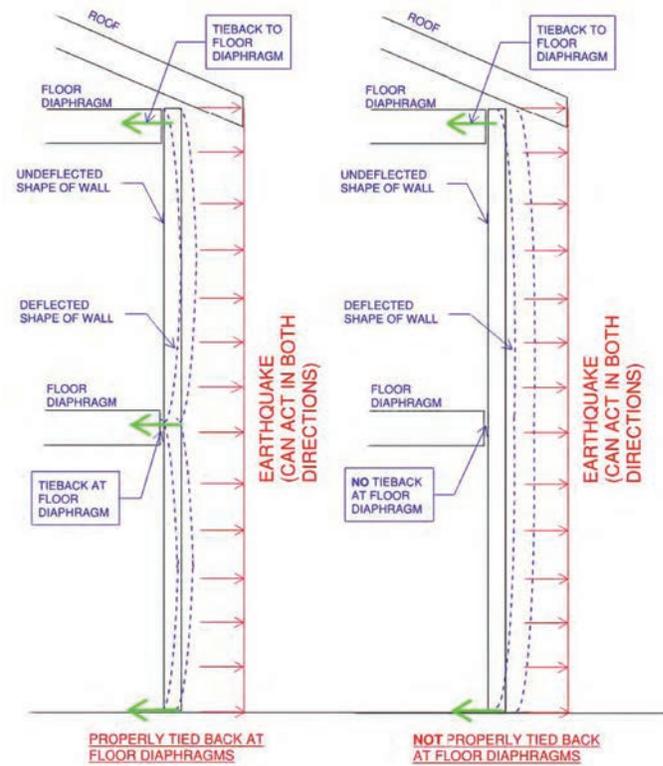
FIGURE 11. The diagram illustrates how floors need to be tied to exterior walls to reduce the amount of lateral deflection and therefore damage to the facades. There was extensive lateral cracking that occurred at the Homestead House because the second floors were not adequately connected. (Diagram by Thornton Tomasetti, Structural Engineers.)

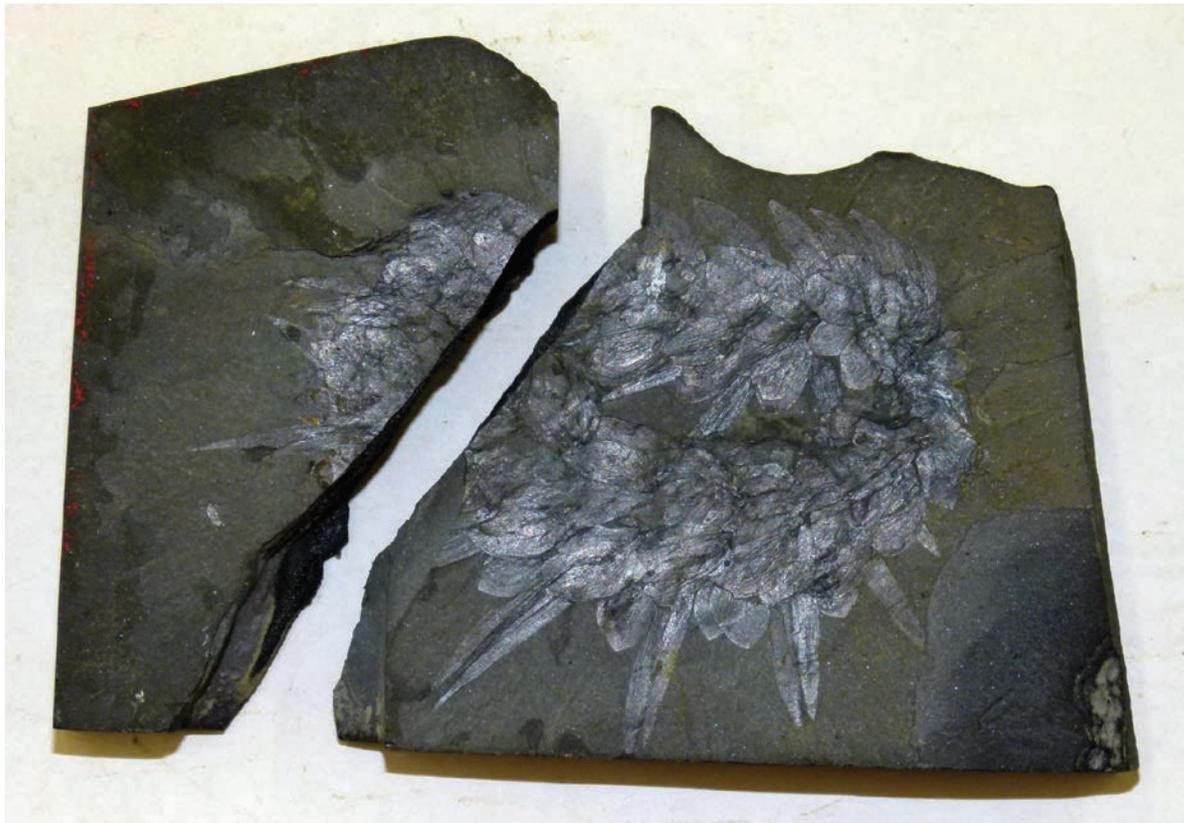
FIGURE 2. Broken slab of Burgess Shale rock containing a 500-million-year-old soft-bodied *Wiwaxia* fossil. (Photo by Steve Jabo, Smithsonian Institution.)

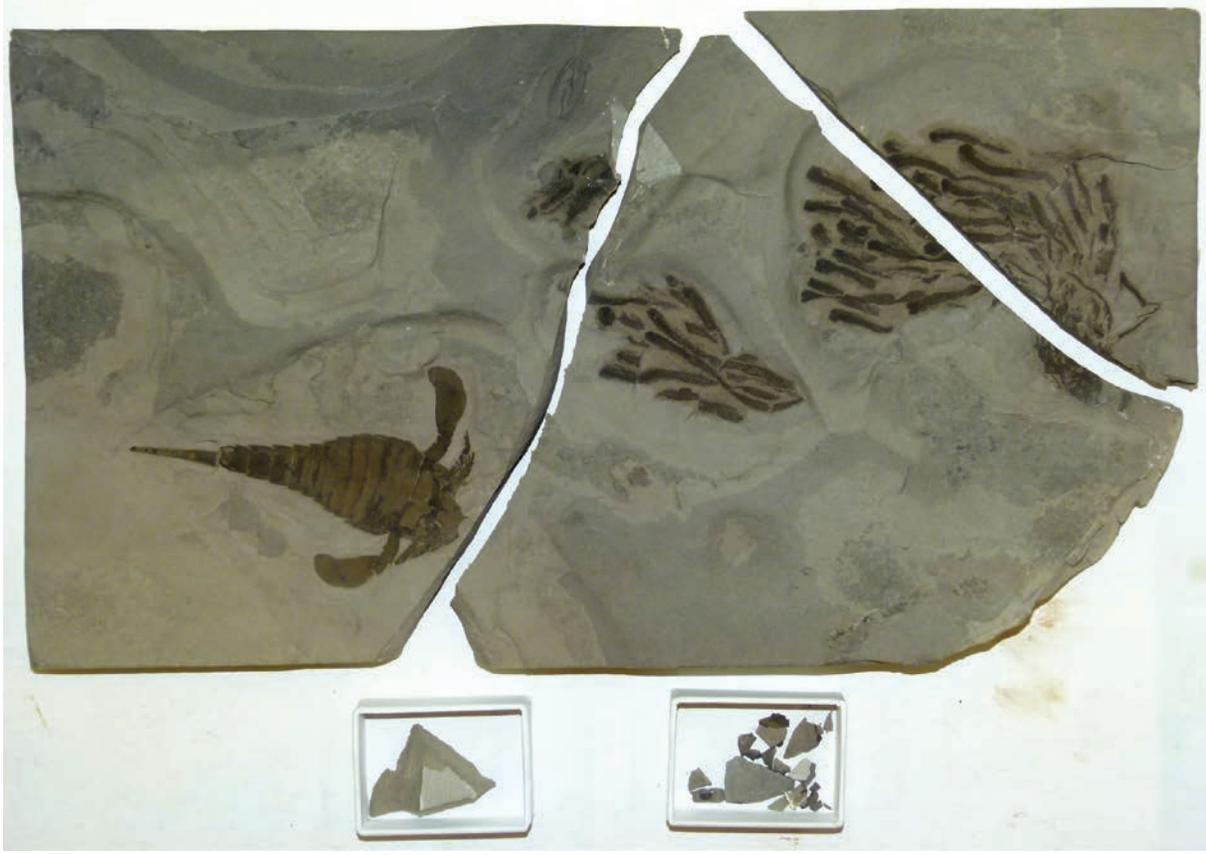
FIGURE 3. Broken slab of limestone containing a 425-million-year-old *Eurypterus* (sea scorpion) fossil. (Photo by Steve Jabo, Smithsonian Institution.)

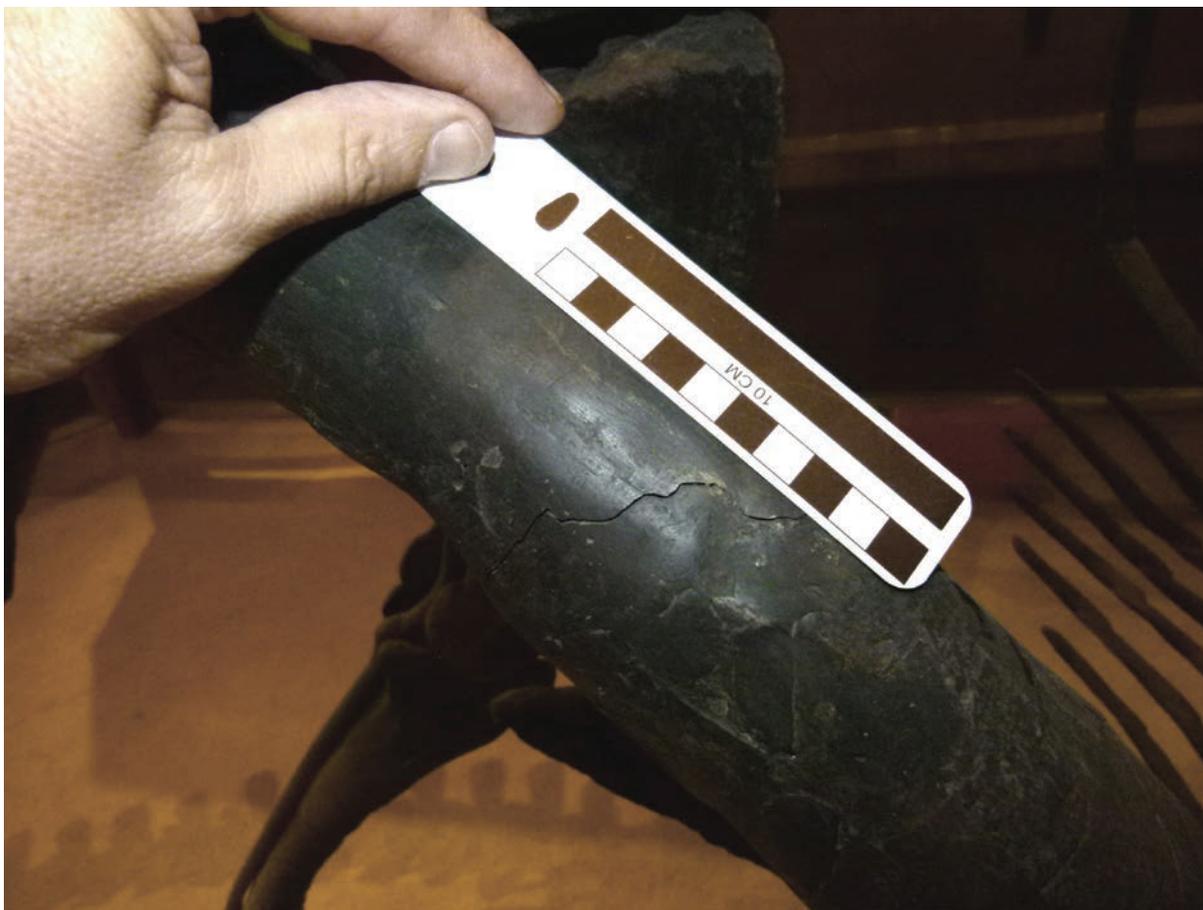
FIGURE 4. The broken femur on the exhibit *Allosaurus* dinosaur. (Photo by Steve Jabo, Smithsonian Institution.)

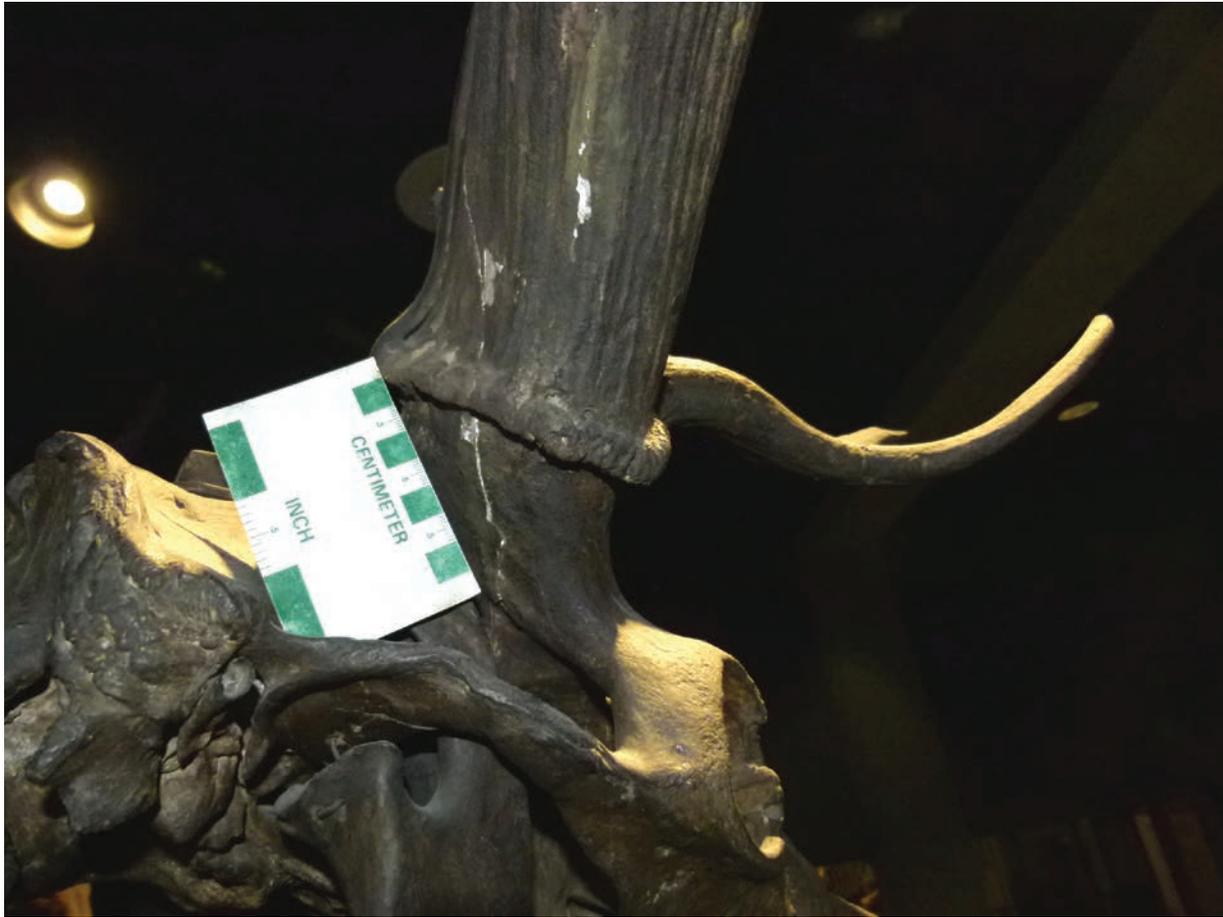
FIGURE 5. Pleistocene-aged Irish elk with a crack through the base of its antler. (Photo by Steve Jabo, Smithsonian Institution.)

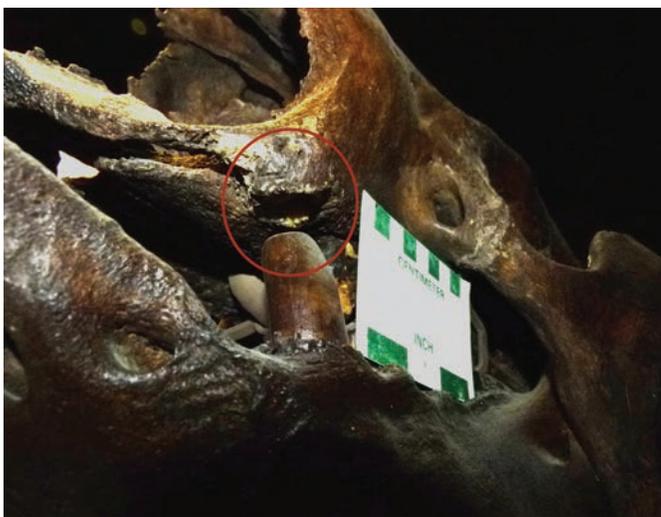
FIGURE 6. Pleistocene-aged giant ground sloth with a broken canine (eye tooth). (Photo by Steve Jabo, Smithsonian Institution.)

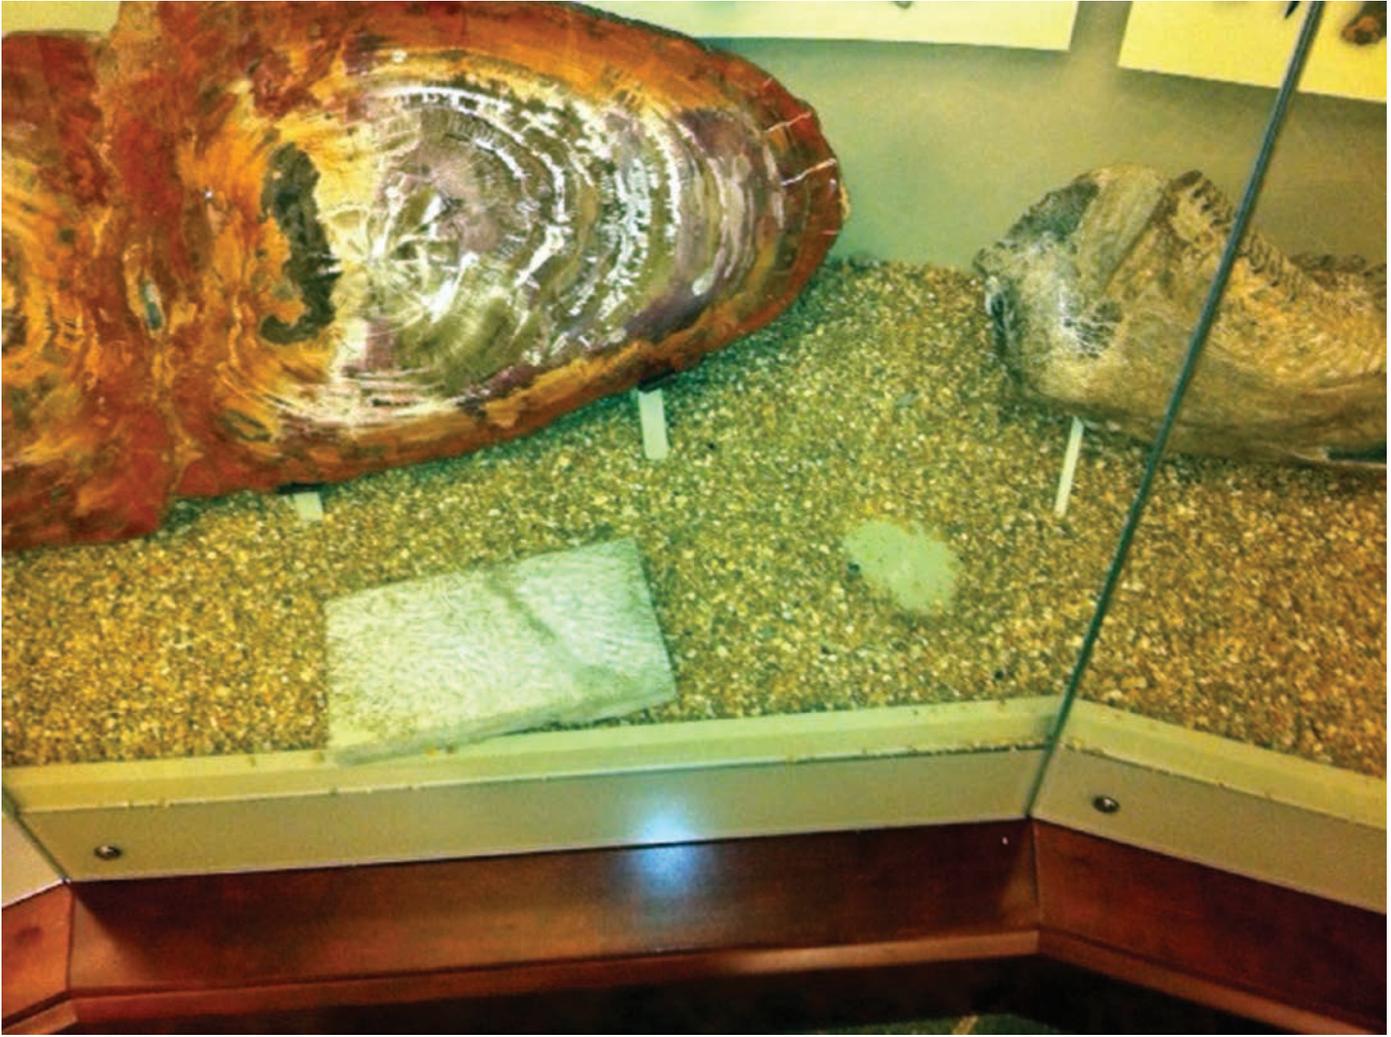
**FIGURE 10.** A fallen slab of limestone containing a crinoid (sea lily) lying in the bottom of the display case in the director's office. The slab hit and damaged the mammoth jaw, on the right, as it fell. There is a divot in the gravel at the bottom of the case where the rock landed. (Photo by Steve Jabo, Smithsonian Institution.)
